Spray Injection Road Repair Contracting Information

SCOPE OF WORK

Sec 1.00 Spray injection repairs to Asphalt or Concrete. Repairs to interstates, highways, county, and township roads including parks and parking lots

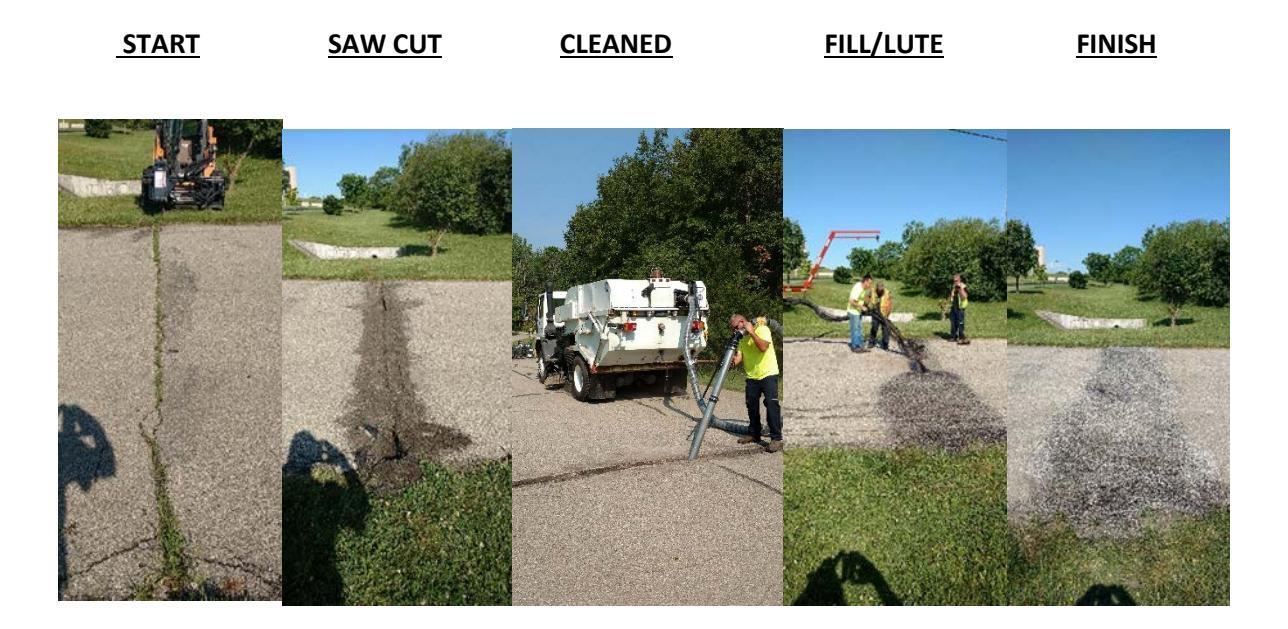
Saw Cut and Fill Application

SAW CUT 4.5" WIDE BY 5" DEEP WITH CASE SKID STEER LOADER AND ALITEC SAW, CUT CLEANED FILLED WITH TERRY MATERIALS POLYFILL EMULSION AND NATIONAL #9 LIMESTONE ROLLED WITH BOMAG BW900 ROLLER

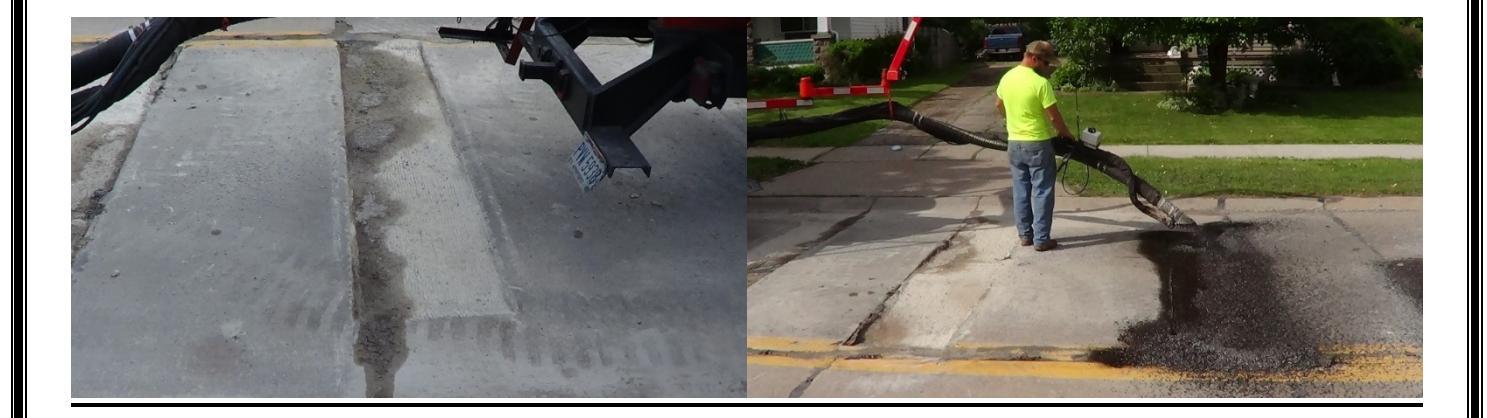
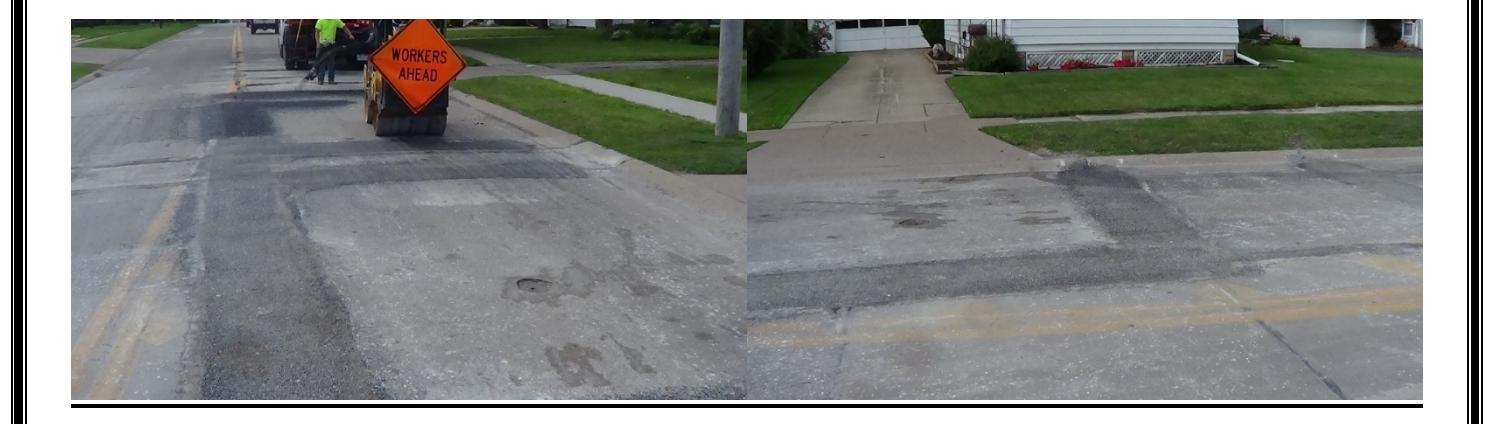
Mill and Fill Application on Concrete

MILLED 24" WIDE BY 2" DEEP WITH CAT 229 SKID STEER LOADER AND CAT MILL FILLED WITH TERRY MATERIALS POLYFILL EMULSION AND NATIONAL #9 LIMESTONE ROLLED WITH BOMAG BW900 ROLLER

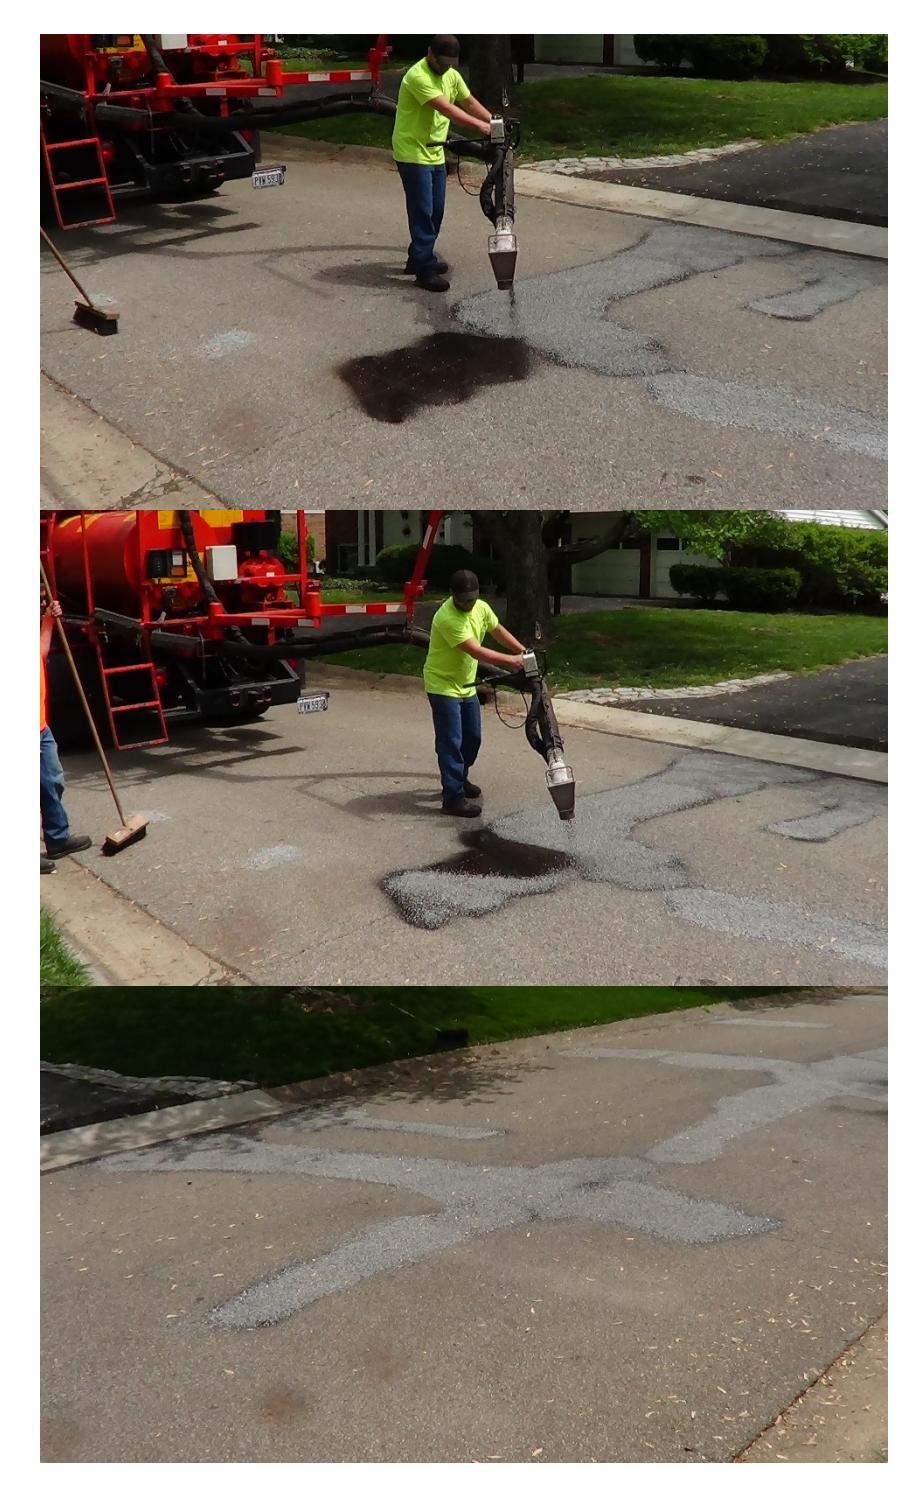
Polyfill Application

Spray Application of Terry Seal Polyfill Emulsion Followed by #9 crushed Limestone Spread Across Emulsion Area and Swept After Patches have Cured

The work consists of preparing surface by cleaning repair area using high volume air flow, then applying a coating of asphalt emulsion to waterproof and seal surface. Next, a mixture of crushed washed limestone and a binder consisting of liquid emulsion is applied until the patch is brought up to grade. Finally a light coating of dry aggregate is spread over the repair.
